## TARMAC PGA STONE WAGONS

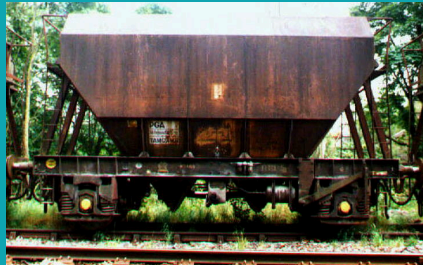
Left : PGA TAMC 14907 at Topley Pike during 1999. As can be seen from the condition of the wagon these have not been used since about 1991 with the end of the Carterhouse Lane (Widnes) traffic and the introduction of the RMC JGAs on the Hope Street, Salford and Bletchley flows which these wagons were used along with the Peakstone PGAs. After the services finished the wagons were stored in the loading sidings at Topley Pike until mid-1999 when they were moved and shunted into the headshunt. The line in the foreground is the Buxton - Great Rocks single line with the headshunt line beyond. PG011B; Standard Wagon, Heywood 1979-80; Tare 12.2t; GLW 51t; Gloucester Floating Axle; Brake lever; Range TAMC 14900 - 921 = 22 wagons.

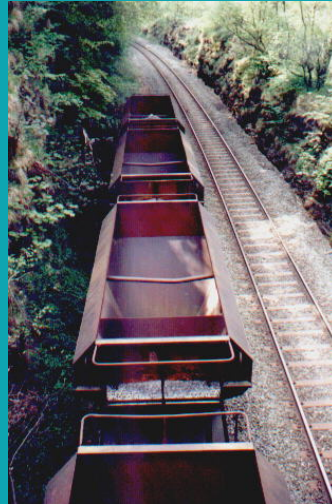
Above Left : The end of the rake of Tarmac PGA wagons as viewed from an occupational overbridge which crosses the line from Great Rocks to Topley Pike thence Buxton. This shows the wagons at the Buxton end of the headshunt at Topley Pike - the wagons were moved from being at the Matlock end of the same headshunt when the new flow of stone from Topley to Pendleton commenced in early 2000. This service uses MEAs and these are generally stored under the stone loader lines or on the Matlock end of the headshunt.

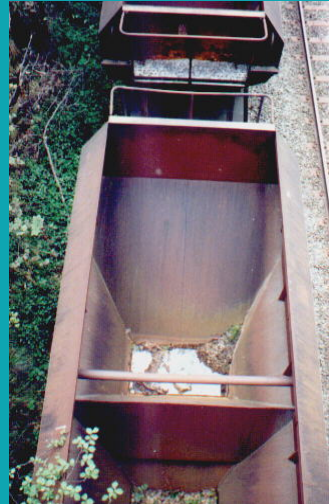
Above Right : A view directly inside one of the PGAs with debris atop of the hopper doors. Note the centre arch which divides the load into half for unloading purposes. A tubular crossbar strengthens the sides of the wagon.

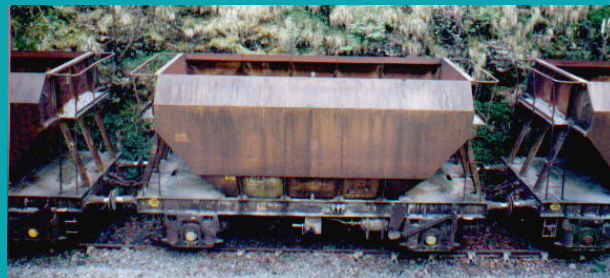
Right : TAMC 14900 the first of the production batch built by Standard Wagon. Note heavy weathering of these wagons and still have lime staining on solebar and ends. All of the wagons are empty. The end inspection platform is at each end of the wagon and the handrails slope outwards on the end of the wagon to provide more working space.

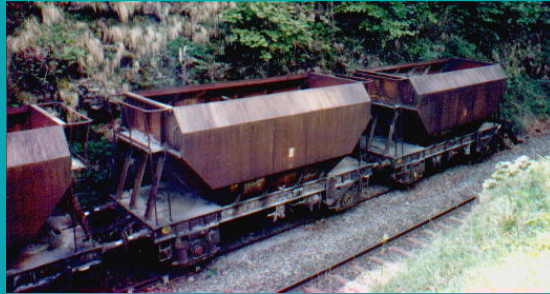
Left: L-R TAMC 14900, 909 and 903 at the end of the headshunt. The line in the foreground continues west towards Buxton.

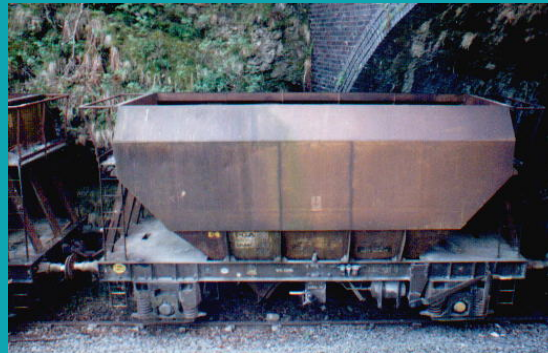
Above: TAMC 14914 just under the aforementioned overbridge. No sign of the RAILEASE lettering that these vehicles once carried on the bodysides. Standard OHLE flash mid-way along bodyside at head height.

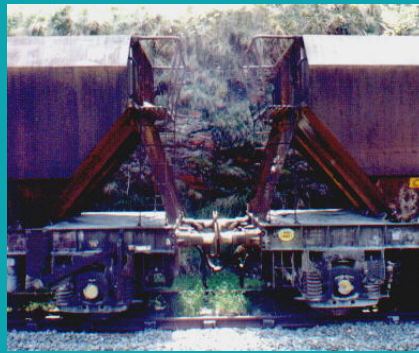
Above Left : Ends of the wagons showing how the handrails slope outwards and buffing details. Wagons have two brake pipes - one Yellow and one Red - only the Red pipe is connected as this is the train air pipe. Instanter couplings are fitted to all wagons.

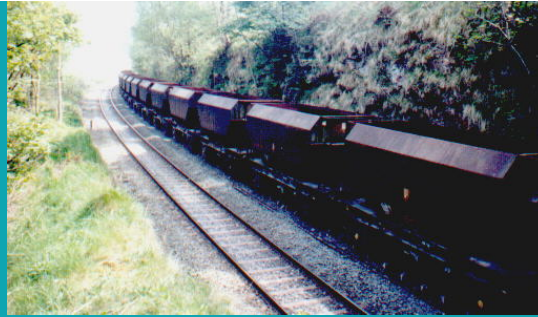
Above : A view of the remaining wagons looking towards the Tarmac sidings at Topley Pike @ 1/4 mile round the curve. The line in the foreground is the single line to/from Buxton. This was relaid using steel sleepers during 1993 after one of the Tunstead - Hindlow limestone trains derailed on this single line section blocking the route. The line was action for a few weeks maybe even a month until re-opened. As the Hindlow runs almost on a daily basis the services were diverted as follows - Tunstead - Peak Forest - Chinley - New Mills South - Romiley - Guide Bridge - Stockport - Hazel Grove - Furness Vale - Buxton - Hindlow and return. The outward journey would be able to run directly onto the Hindlow branch but the return working would have had to go into Donarue sidings and reverse into the station before being able to take the Down line to Stockport.
